# DEVELOPMENT OF A UNIQUE ACCELERATED IRON CORROSION TEST ( AICT ) TO STUDY CORROSION TENDENCIES IN A WIDE RANGE OF FUELS

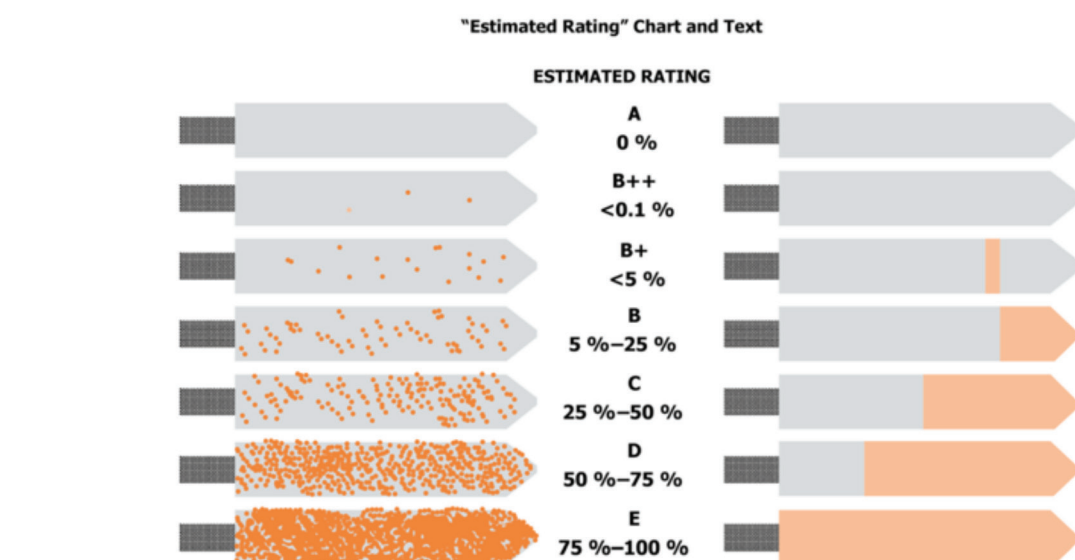
Figure 2: "Estimated Rating" Chart and Text for amount of rust forming associated rust grading

ASTM D7548 is conducted with an iron test-rod which is put in a sample of the test material at 37.8°C and is then mixed with 5 mL of type three or better reagent water. In order to heat the mixture, the test is conducted on a stirring hotplate with a speed of 900 ± 100 rotations per minute (RPM). In preparation, the iron rod must be cleaned with acetone and a grinding and polishing apparatus with a C-100 abrasive cloth which is used to clean off any rust and then to form circular grooves and polish off the test rod to get rid of any rust that has been left from previous tests. Before doing the test, it is important to clean the test jar and magnetic stirring bar so that it does not have a thin film of rust on it. If either the jar or the stirring rod has thin film of rust on it, use 15% hydrochloric acid to clean off any rust. With preparation completed, it is now possible to start the test. To start off the test, there should be a jar cover which would allow for the mounting of the iron rod. With that part of the assembly put together, 50 mL of the test sample should be poured into the jar with the magnetic stirring rod placed into the jar shortly after. The entire assembly is submerged into a water bath which is at a temperature between 37°C to 39°C with an initial speed of 100 RPM. Once the sample has hit the target temperature between 37°C to 39°C, using a syringe, inject the type III reagent water into the sample and take note of the time. As time passes, increase the RPM of the magnetic stirring bar to 900 RPM. Once the total test time has hit the one-hour mark after the addition of the water into the sample, it is now possible to remove the assembly. Remove the iron rod and within five minutes inspect with the help of magnifying glass with 2x magnification and take note of the results. The result of the test is based on a rating chart in the ASTM testing documentation called the "ASTM Iron Corrosion Rating".

The rating goes from a scale from A to E, where a score of A means that there was no rust that was seen on the iron rod. A score of D or higher means that 50% or more of surface area of the iron rod is covered by rust. A detailed image of the amount of rust on the surface of the iron rod means what percentage of its surface is covered and what rating that should be given to the sample that was tested [8]. Once the entire test has been completed, it is possible to properly dispose of the chemicals that were used to conduct the test.

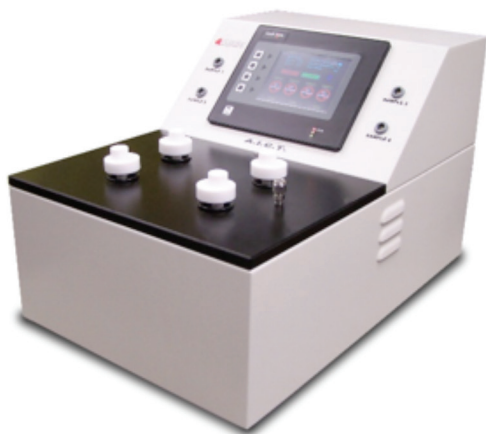
Figure 3: Image of the K30260 Determination of Accelerated Iron Corrosion in Petroleum Products

One instrument that can perform the test is the K30260 manufactured by the Koehler Instrument Co. The instrument comes with the ability to perform four tests at a time. Also, the instrument comes with a five-inch touch screen with soft keys for accessible user experience. The unit comes with all the specification to perform the test with the temperature and RPM with the accordance of the ASTM method [9]. When ordering the instrument, it comes with the four temperature probes, four test jars with the necessary caps, the test rods and the magnetic string rods. The instrument also comes with a list of optional accessories which are a polishing chuck, driver motor and a silicone carbide abrasive cloth. More information about everything that instrument comes with can be found through the company's website.
