FLIR GF320 THERMAL CAMERA OFFERS RELIABLE GAS LEAK DETECTION IN BIOGAS FACILITIES

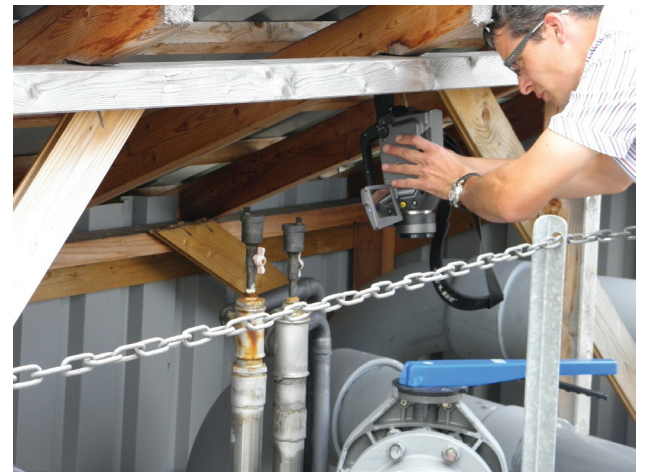
Engineer Ibeling van Lessen looking for gas leaks, which is possible from a safe distance and unusual angles using the FLIR GF320.

As a result, van Lessen was looking for a non-contact method for detecting small leaks from a distance. The FLIR GF320 fit the bill. It was compact and mobile, and can identify small gas leaks from several meters away, and big leaks from hundreds of meters away without requiring equipment be shutdown.

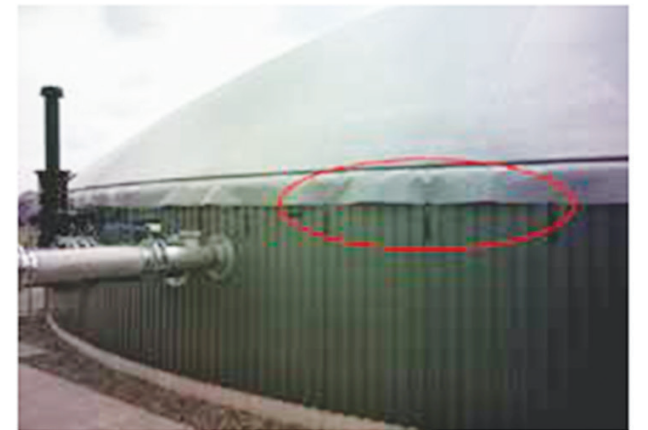
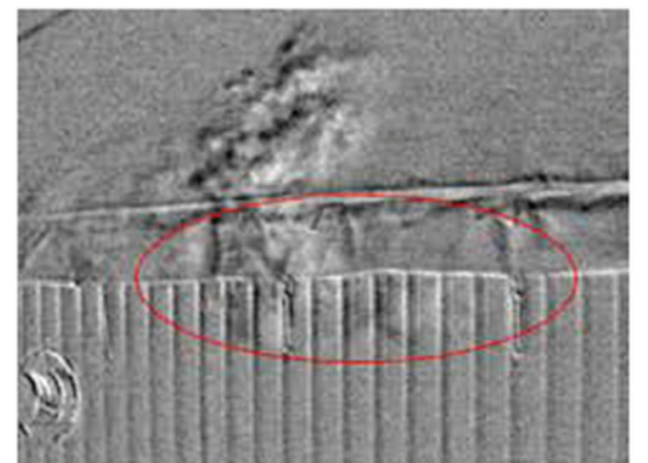
Gas leak on the terminal strip of the air-supported roof of a fermenter in the visible light spectrum - and in an infrared image made by the FLIR GF320.

Escaping gases appear like smoke on the camera's LCD viewfinder in real time and can be recorded in the camera for easy archiving. Once a leak is detected from a safe distance, users can move closer and quantify the gas concentration using a secondary method.

FLIR Tools software also comes in quite handy when producing inspection reports. The software allows for sophisticated documentation and is easy to learn in a short period of time. Found leaks can be marked directly in the image and also recorded as a video sequence inside the program. Based on detailed reports, damaged areas can be subsequently repaired by the customer, and then tested again to confirm the leak is fixed.

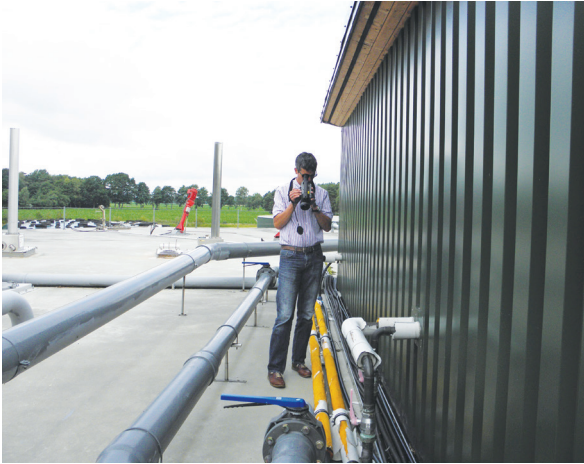
Explosion protected areas can be investigated from a safe distance with the FLIR GF320.

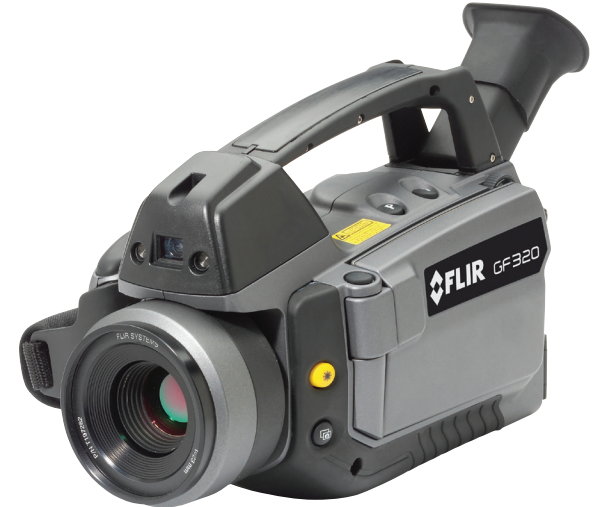
The FLIR GF320 thermal imager.
